# MILLE LACS RESERVATION TRIP REPORT

## Assessment of Mold and Moisture Conditions

### Final Report

Date:  
May 27-30, 2003

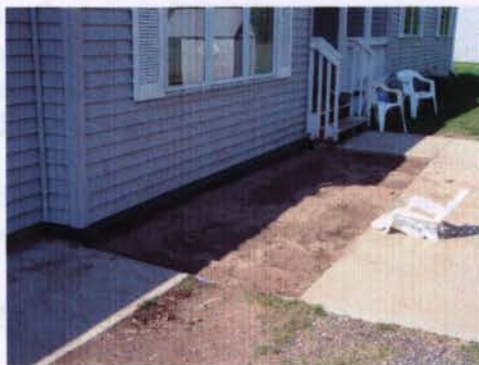
Site drainage was poor at 17 homes. Site drainage was either flat or pitched toward the foundation (Figure 3). Twelve of fifteen interior inspected homes had wet crawl spaces or half basements. One crawl space had approximately 6" of standing water. This house was sitting very low to the ground giving the appearance that it was built on a slab rather than over a crawl space (Figure 4). Five split level homes were inspected. These homes had finished living spaces in the half basement. Three of the five split level homes had visible mold in these living spaces. Two of these three homes were over 20 years old. Site drainage work had recently been completed around the basement area the third home.

Figure 3 – Flat site drainage adjacent to home

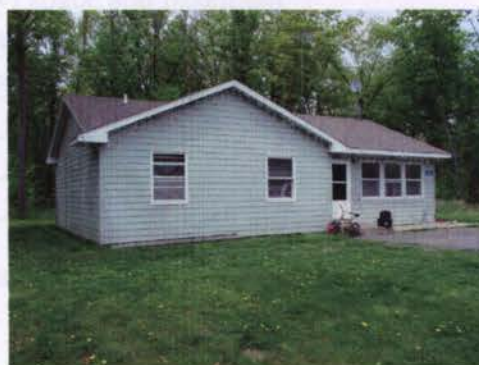
Figure 4 – House appears to be on a slab rather than a crawl space. About 6" of water was found in the crawl space.

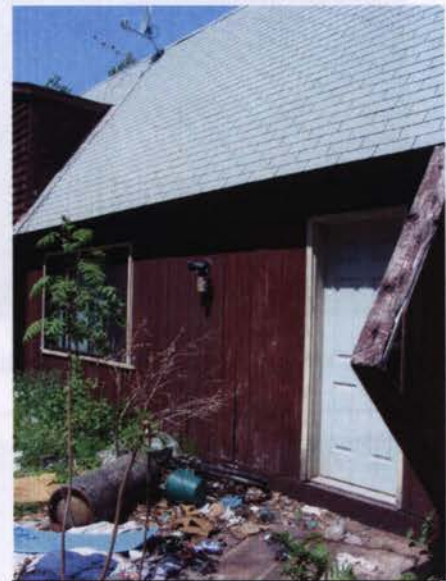
**Figure 7 – Rainwater collects at base of house**

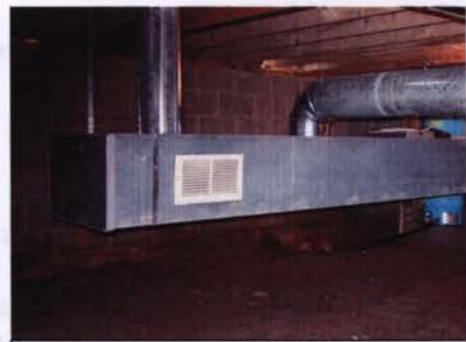
Figure 8 – Open supply register

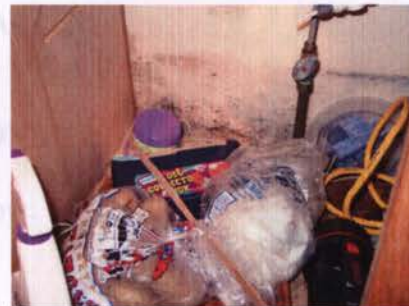
Figure 16 – Mold under kitchen sink due to previous leak

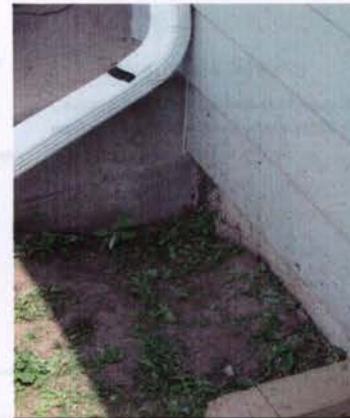
**Figure 22 – Low spot adjacent to foundation. Note flip-up leader.**

- Continued use of flip-up leaders and splash blocks to direct water away from foundations.
- Instruct occupants on the importance of downspouts, flip-up leaders and splash blocks and maintaining these items in good condition.

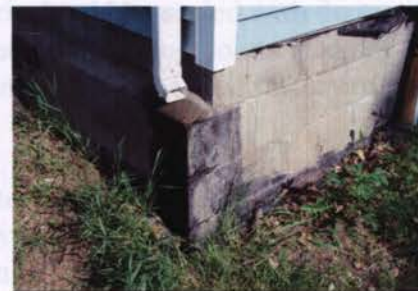
**Figure 23– Missing leader**

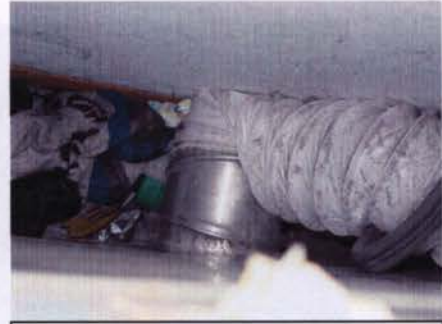
Figure 26 – Crimped dryer vent

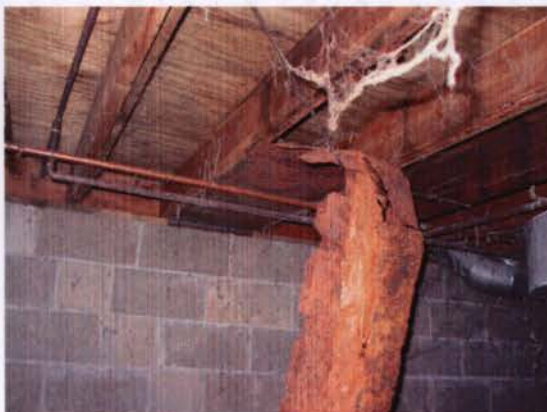
**Figure 28 – Rusty panned return duct in crawl space.**

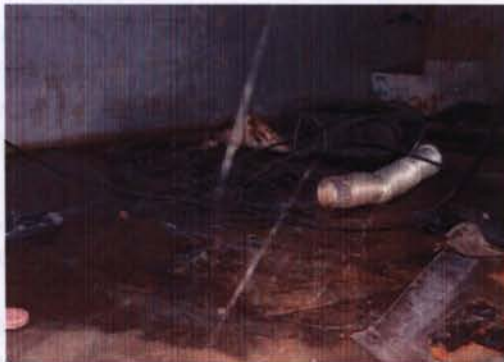
**Mold and Moisture Conditions:** The house had experienced flooding in the crawl space. Standing water was present in parts of the crawl space as was moldy debris (Figure 2). Mold was found on the drywall between the crawl space and house (Figure 3). Mold was also present in the utility room and spare room of the half basement (Figure 4). The furnace room was open to the crawl space and there was no door on the furnace room thus the crawl space was open to the entire house. The filter slot was open in the utility room (Figure 5). In addition, there was a hole in the living room floor to the crawl space. Mold was also found in the lower level bathroom.

Figure 2- Standing water/debris in crawl space

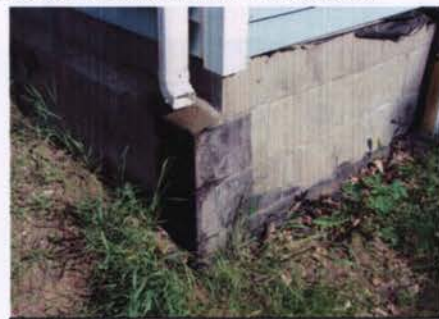
Site drainage looked good and gutters were present, however, leaders were missing (Figure 2). Polyethylene material was used as foundation wall waterproofing. Much the polyethylene was ripped and missing from the above grade foundation wall (Figure 3).

Figure 2 - Missing leader

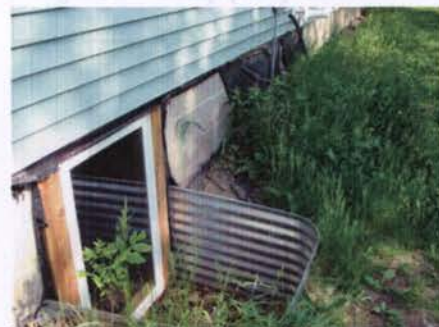
Figure 3 – Basement window well. Note polyethylene material on block wall.

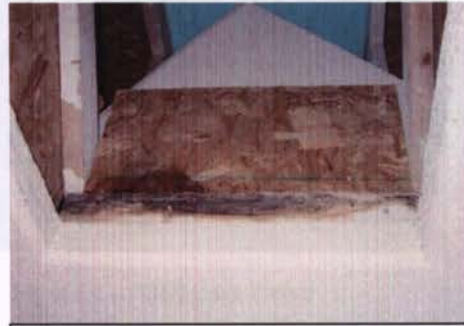
Figure 4 – Mold on insulation dam

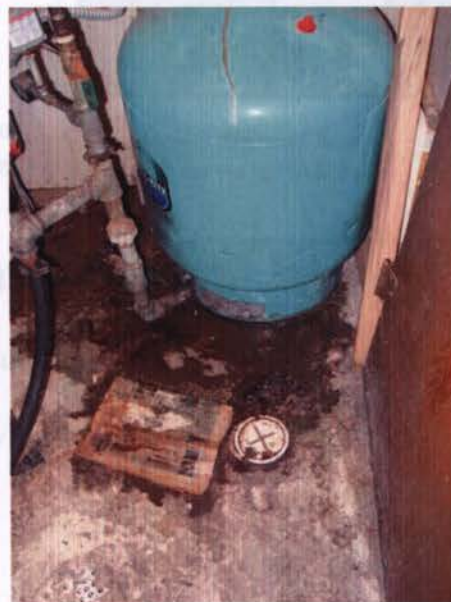
Figure 2 – Leak from water pressure tank

- Correct flame rollout condition (this condition was going to be corrected immediately by the housing authority).
- Repair or replace water pressure tank.
- Fix leak beneath kitchen sink and clean mold if present.
- Replace both bathroom exhaust fans.
- Install kitchen exhaust fan that vents to the outside.
- Install gutters and downspouts.
- Close the open supply air register in the crawl space.

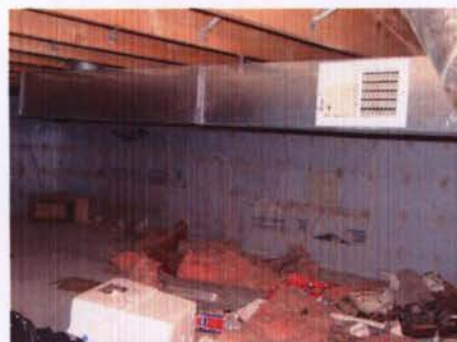
Figure 3 – Open supply air register in crawl space

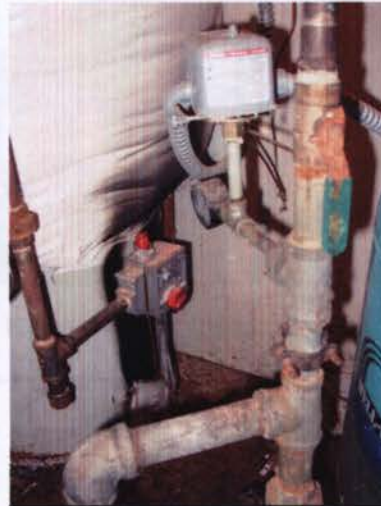
**Figure 4 – Signs of flame rollout on water heater jacket**

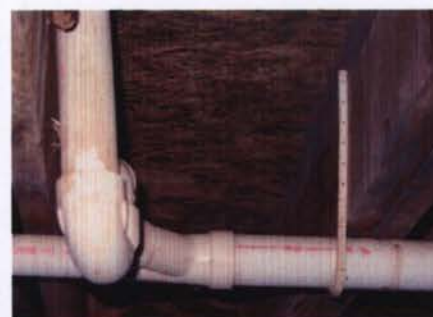
**Figure 3 – Moldy sheathing under bathtub.**

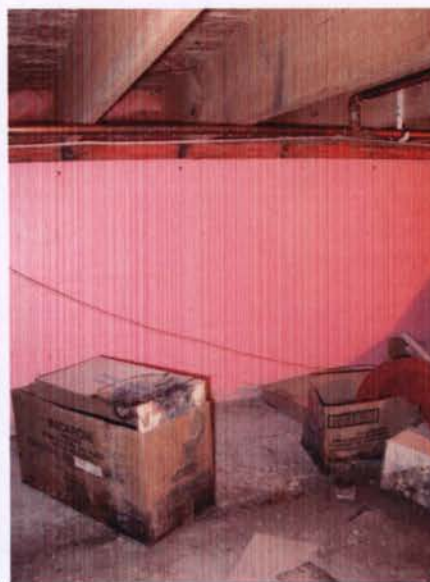
**Figure 2 – Moldy debris in crawl space – note drip line beneath copper pipe**

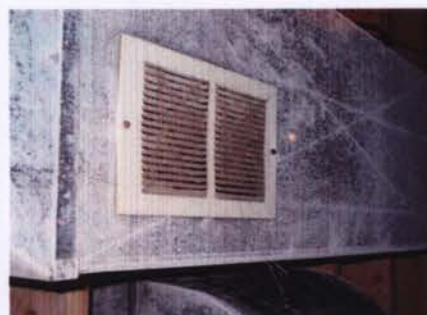
**Figure 3 – Return air grille on crawl space – note dirt on grille.**

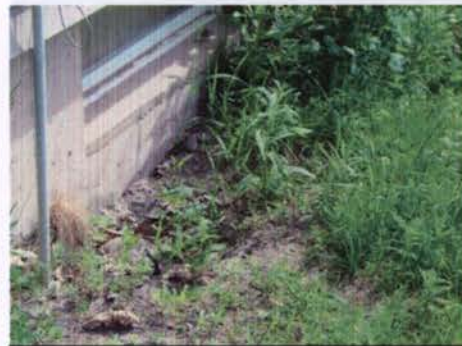
Site drainage was flat with some low spots around the foundation (Figure 2). Gutters and downspouts were present. The fresh air intake to the heat recovery ventilator (HRV) was clogged (Figure 3).

Figure 2 – Low spot at foundation.

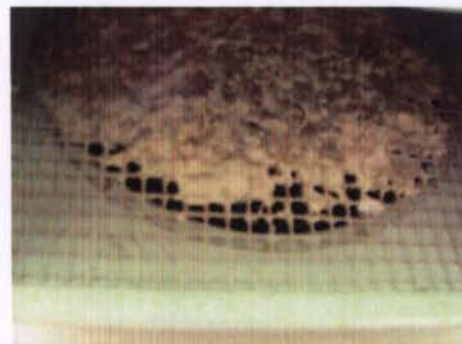
Figure 3 - Clogged HRV instake

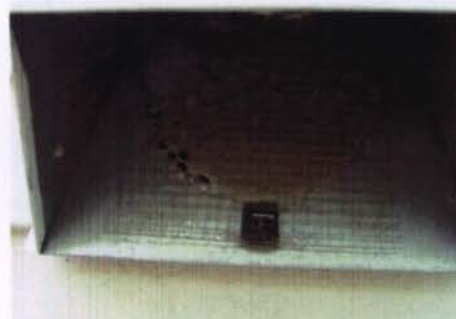
Figure 4 – Clogged fresh air intake to HRV

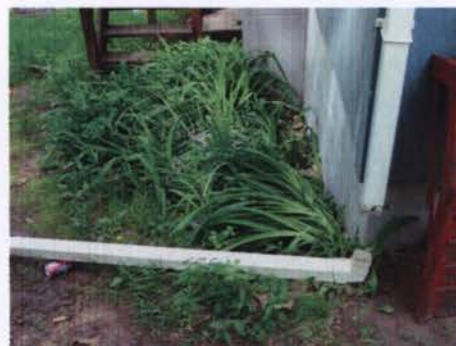
Site drainage was fairly good except for walk-out basement in rear of home. It appeared that water could collect at this point from drainage along side of home. Gutters and downspouts were present, but some of the leaders were missing or not connected (Figure 2).

Figure 2 – Disconnected leader

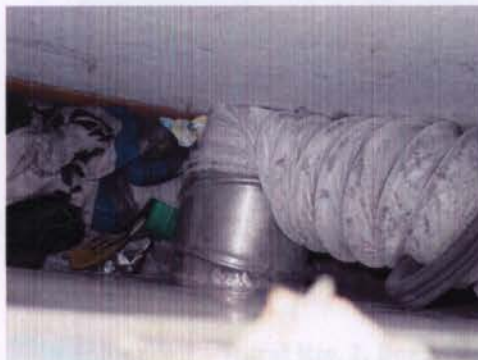
Figure 4 – 90° bend at dryer exhaust outlet

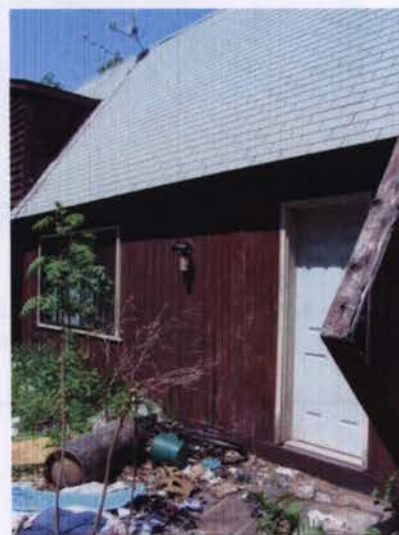
Figure 2 – Water drains next to the crawl space

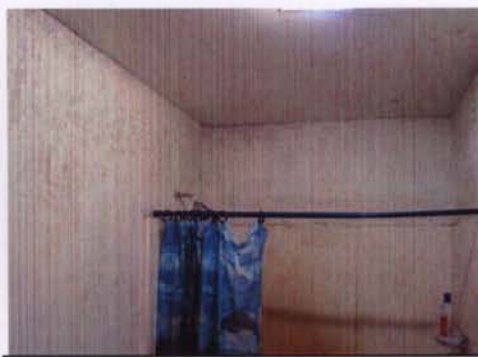
**Bathroom/Kitchen:** The kitchen fan vented to the outside, but was non-operational. Standing water was found in a pan beneath the kitchen sink. The main level bathroom exhaust fan measured 17 CFM. The lower level bathroom exhaust fan measured 0 CFM. Both bathrooms were very moldy (Figure 4). Mold was also found in the lower level bedrooms.

Figure 4 – Mold in bathroom

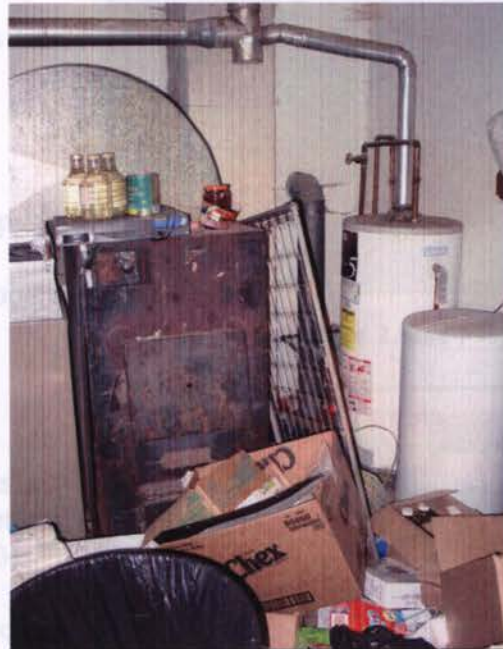
**Figure 5 – Clutter in furnace room.**  
Note 6" diameter duct in background – fresh air supply to return side of furnace

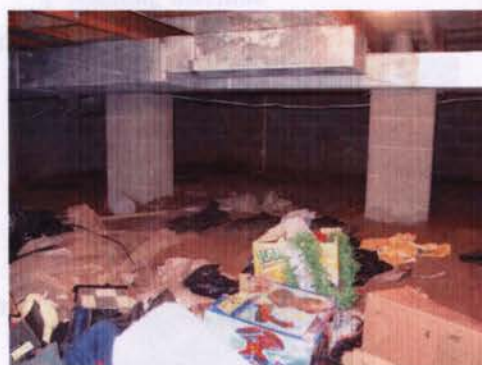
Figure 2 – Crawl space clutter

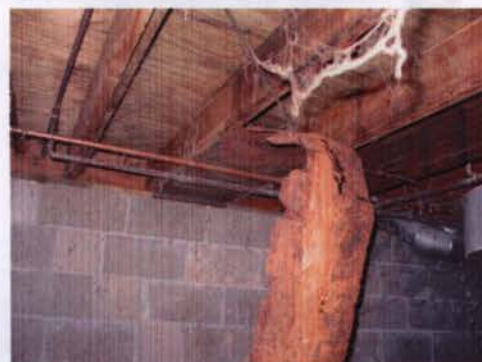
Figure 3 – Rusted panned return

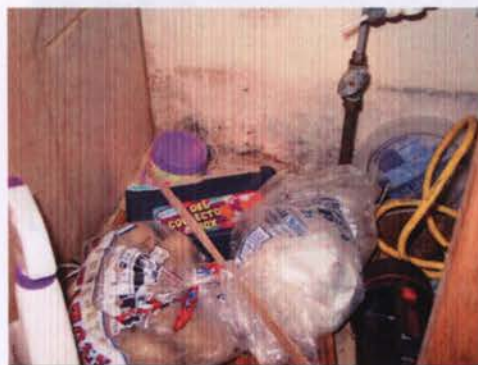
Figure 4 – Mold beneath kitchen sink

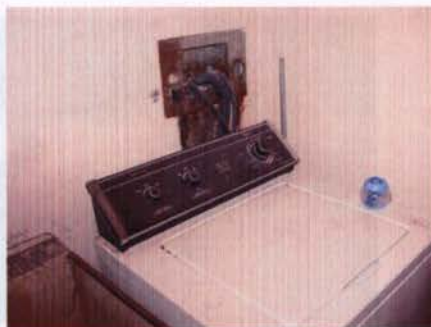
Figure 5 – Water damage behind washing machine

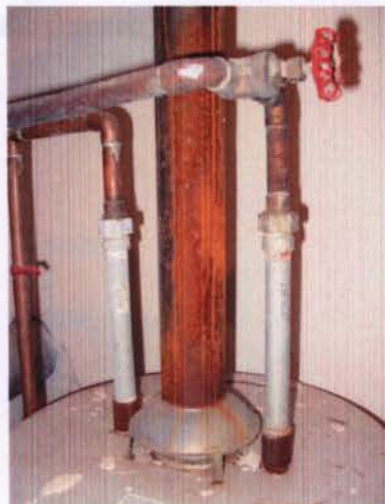
Figure 8 – Rusted flue

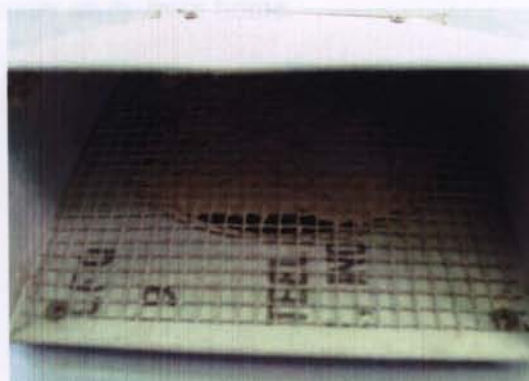
Figure 7 – Clogged fresh air intake

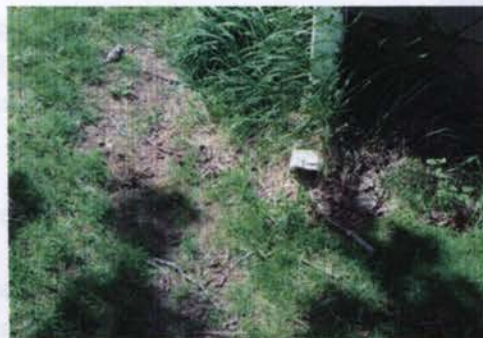
Figure 2 – Missing leader on downspout

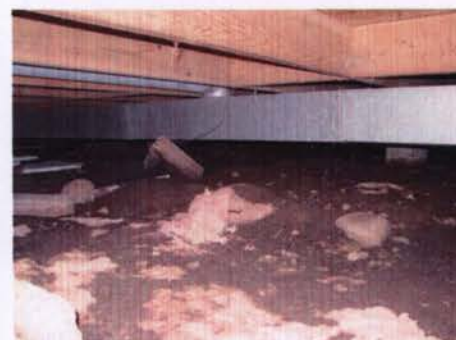
Figure 4 – Wet crawl space

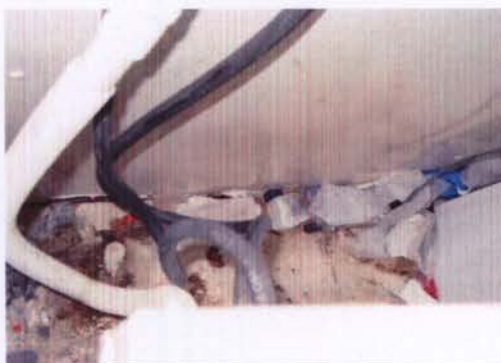
Figure 5 – Water stains behind washer

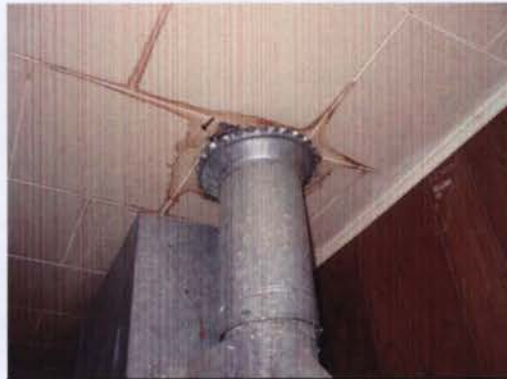
**Figure 6 – Water stains from previous roof leak**
